Manhole Inspection Summary

Manhole # S53E__030MH

Insp Date: **4/29/08 9:38 AM**

Location Address: **140 s clinton at**

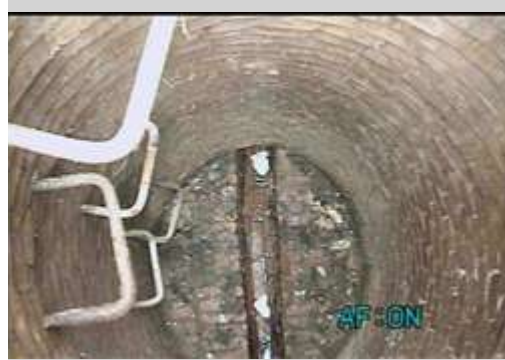
Top View

Condition: **Sound**

Condition: ☒ Sound ☐ Cracked ☐ Root Intrusion ☐ Loose Brick ☐ Deteriorated

Condition: ☒ Sound ☐ Cracked ☐ Root Intrusion ☐ Deteriorated ☐ Leaks ☐ Debris

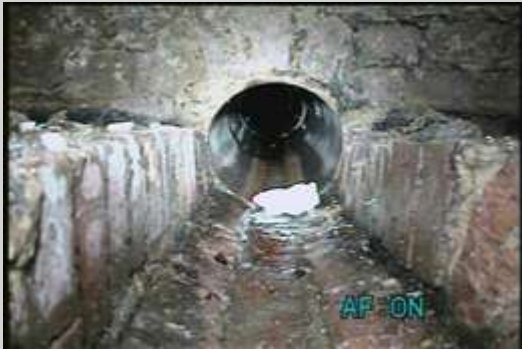
12 O'Clock Outflow

8 in. Circular Gravity Sewer
Pipe Out @ 12 O'Clock

Pipe Material: **Clay** ☐ Pipe Lined

Invert Depth: **9.50** (ft.) Flow Characteristics: **Slow**

Deposits: ☒ None ☐ Mud ☐ Sludge ☐ Debris ☐ Grease

Infiltration: **None** Pipe Seal Cond: **Unknown**

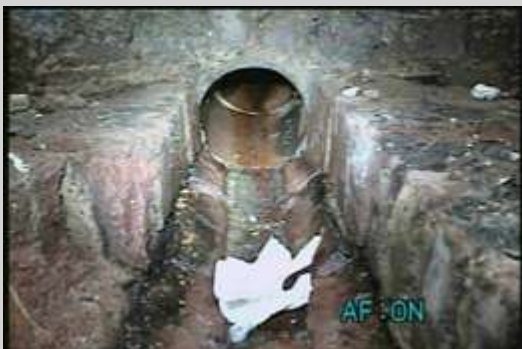
6 O'Clock Inflow

8 in. Circular Gravity Sewer
Pipe In @ 6 O'Clock

Pipe Material: **Clay** ☐ Pipe Lined

Invert Depth: **9.10** (ft.) Flow Characteristics: **Slow**

Deposits: ☒ None ☐ Mud ☐ Sludge ☐ Debris ☐ Grease

Infiltration: **None** Pipe Seal Cond: **Unknown**

Connects To: **Dead End**
